“Full” Reserve Study

Brighton East Farms M.A. Brighton, CO

Report #: 31560-0
For Period Beginning: April 1, 2016
Expires: March 30, 2017

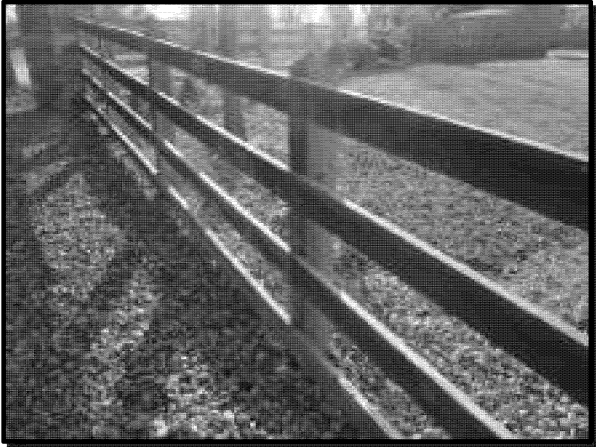
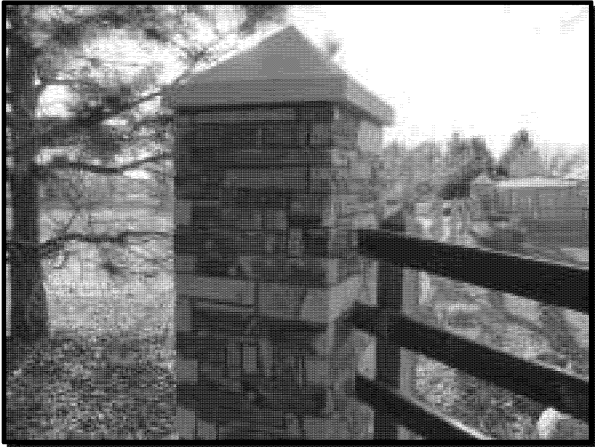
During our site visit on October 27, 2016, we started with a brief meeting with the board, and then started the site inspection beginning with the common grounds. We visually inspected the common areas.

Please see photo appendix for component details; the basis of our assumptions.

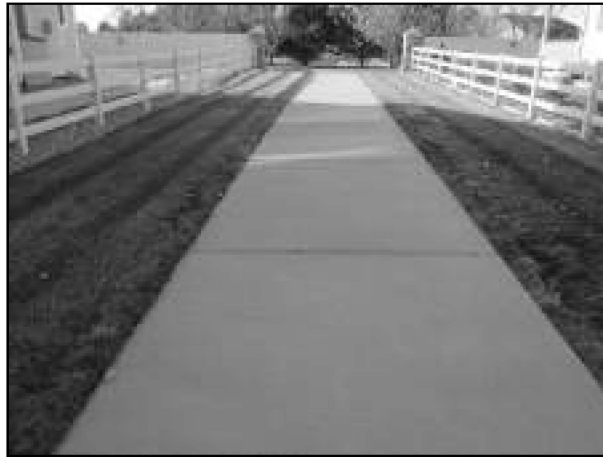
Comp #: 2115 Concrete Walkways - Repair - 1%

Evaluation: No major issues were observed at the time of the inspection. Colorado is home to expansive soils. One of the causes of concrete damage in this type of soil moisture. Expansive soils tend to swell in size when wet and contract as they dry out. As the soil expands and contracts it can create enough force to cause major damage to sidewalks. Repair any trip and fall hazards immediately to ensure safety. As routine maintenance, inspect regularly, pressure wash for appearance and repair promptly as needed to prevent water penetrating into the base and causing further damage. In our experience, larger repair/replacement expenses emerge as the community ages. Although difficult to predict timing, cost and scope, we suggest a rotating funding allowance to supplement the operating/maintenance budget for periodic larger repairs. Adjust as conditions, actual expense patterns dictate within future reserve study updates.

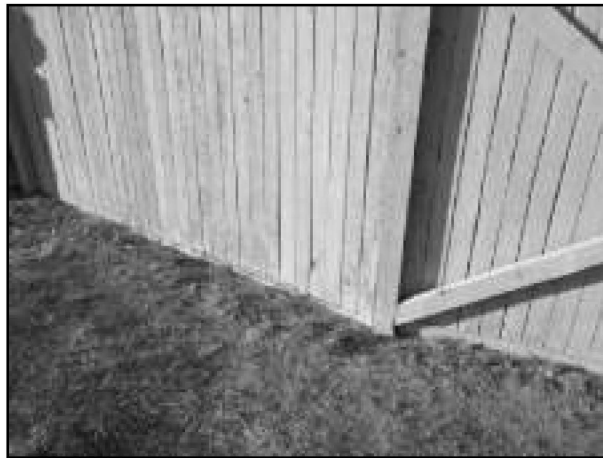
Comp #: 2151 Site Fencing: Wood - Repair/Paint

Evaluation: The finish on the wood fence appeared in generally poor condition. Reported that the fences have not been sealed or stained.

Regular sealer applications are recommended for the appearance, protection, and maximum useful life of the wood. Actual timing of staining will vary based on exposure and quality of material and application. In our experience, quality solid-bodied stain typically produces best result. Remove any unnecessary contact with ground and surrounding landscape and sprinkler patterns. Repair as needed and clean prior to sealer application.

Client does not anticipate staining or sealing the fence therefore no funding has been provided.

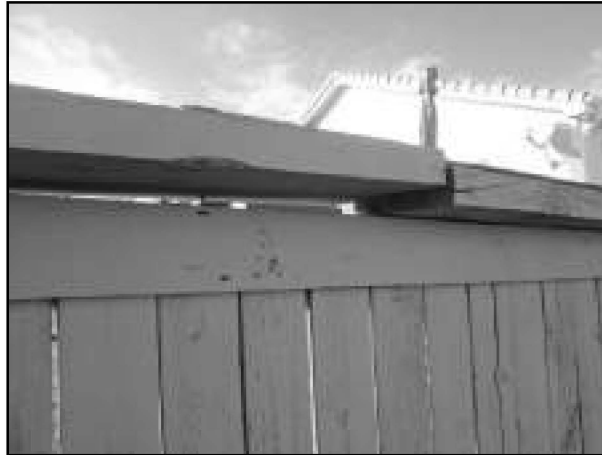
Comp #: 2155 Site Fencing: Wood - Replace (Ph 1)

Evaluation: 6' privacy fence. Minor breakage and leaning of the fences noted in local areas. As routine maintenance, inspect regularly for any damage, repair as needed and avoid contact with ground and surrounding vegetation wherever possible. Regular cycles of uniform, professional sealing/painting will help to maintain appearance and maximize life. Plan to replace at roughly the time frame below with funding included here for similar wood replacement. At next replacement, association might want to consider replacing with more sturdy, lower-maintenance products like composite, vinyl, etc. Although installation costs are higher, total life cycle cost is lower due to less maintenance and longer design life expectancy.

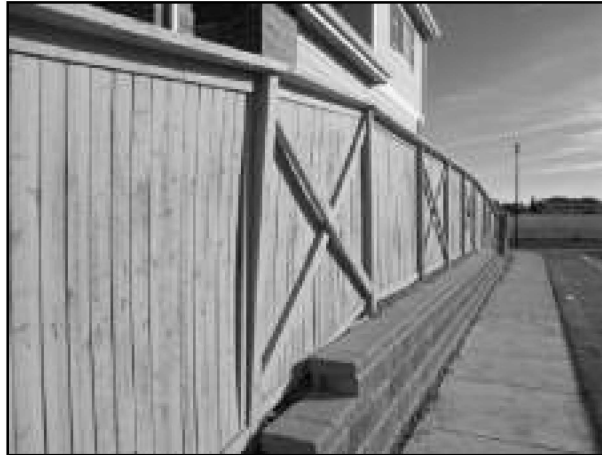
Comp #: 2155 Site Fencing: Wood - Replace (Ph 2)

Evaluation: 6' privacy fence. Minor breakage and leaning of the fences noted in local areas. As routine maintenance, inspect regularly for any damage, repair as needed and avoid contact with ground and surrounding vegetation wherever possible. Regular cycles of uniform, professional sealing/painting will help to maintain appearance and maximize life. Plan to replace at roughly the time frame below with funding included here for similar wood replacement. At next replacement, association might want to consider replacing with more sturdy, lower-maintenance products like composite, vinyl, etc. Although installation costs are higher, total life cycle cost is lower due to less maintenance and longer design life expectancy.

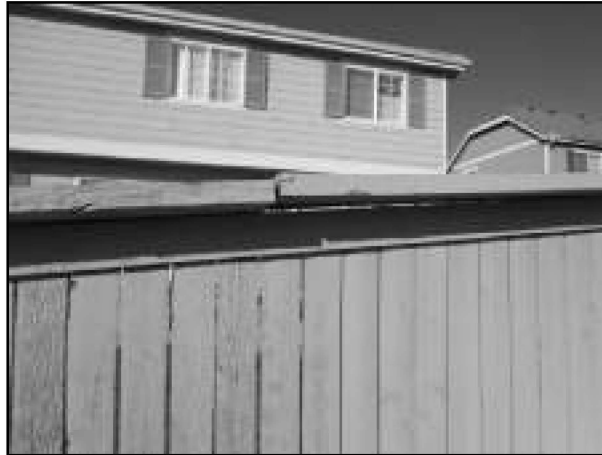
Comp #: 2155 Site Fencing: Wood - Replace (Ph 3)

Evaluation: 6' privacy fence. Minor breakage and leaning of the fences noted in local areas. As routine maintenance, inspect regularly for any damage, repair as needed and avoid contact with ground and surrounding vegetation wherever possible. Regular cycles of uniform, professional sealing/painting will help to maintain appearance and maximize life. Plan to replace at roughly the time frame below with funding included here for similar wood replacement. At next replacement, association might want to consider replacing with more sturdy, lower-maintenance products like composite, vinyl, etc. Although installation costs are higher, total life cycle cost is lower due to less maintenance and longer design life expectancy.

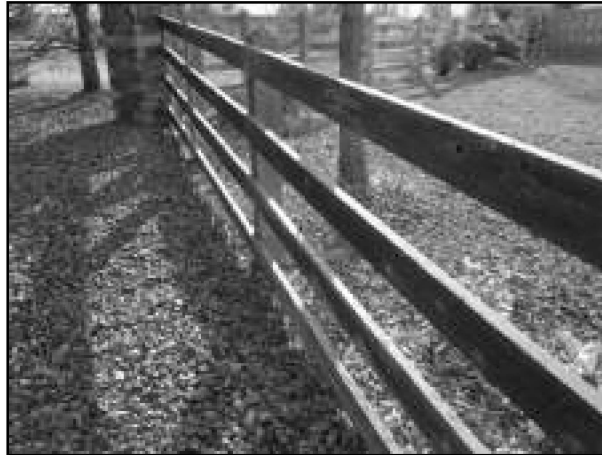
Comp #: 2157 3-Rail Wood Fence - Replace

Evaluation: No major issues were noted. As routine maintenance, inspect regularly for any damage, repair as needed and avoid contact with ground and surrounding vegetation wherever possible. Regular cycles of uniform, professional sealing/painting will help to maintain appearance and maximize life. Plan to replace at roughly the time frame below with funding included here for similar wood replacement. At next replacement, association might want to consider replacing with more sturdy, lower-maintenance products like composite, vinyl, etc. Although installation costs are higher, total life cycle cost is lower due to less maintenance and longer design life expectancy.

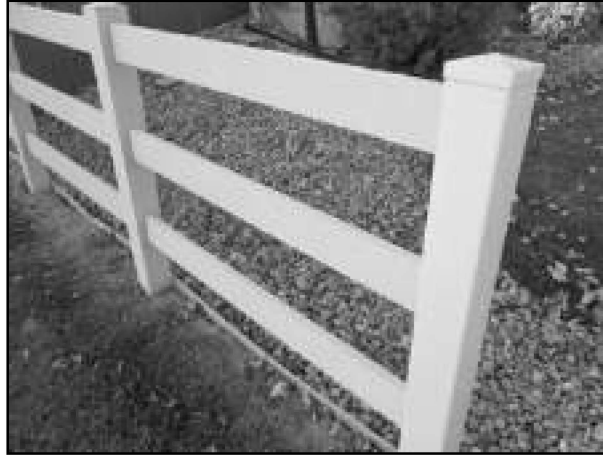
Comp #: 2159 3-Rail Vinyl Fence - Replace

Evaluation: Three rail fence. No major issues were reported or noted. No broken rails noted. As routine maintenance, inspect regularly for any damage and repair as needed from Operating budget; clean as general maintenance item or along with larger building projects, not as separate Reserve item. Even with proactive maintenance, plan to replace at roughly the time frame below due to damage/deterioration that will result from constant exposure.

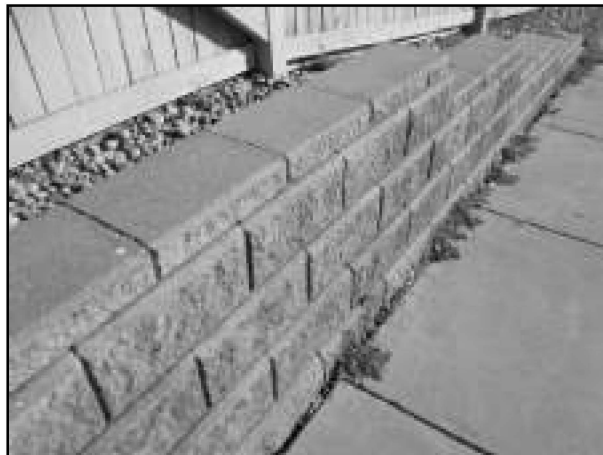
Comp #: 2165 Retaining Walls - Repair

Evaluation: No significant or widespread cracking, settling or other problems observed. Assumed to have been properly designed and installed with adequate base and surrounding drainage. Inspect regularly, repair as needed from Operating budget. If shifting, cracking, etc. are observed, consult with civil or geotechnical engineer for repair scope. At this time, no expectation of large scale repairs or replacement; no Reserve funding recommended. An allowance for partial repairs/replacements may be added during future Reserve Study updates if warranted by association history.

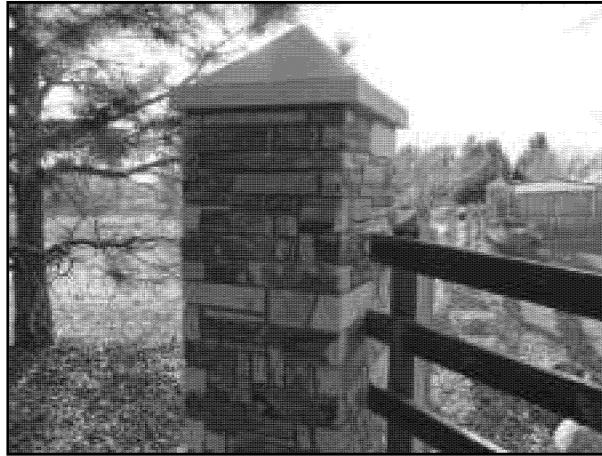
Comp #: 2168 Stone Columns - Repair

Funded?: No. Repair as needed

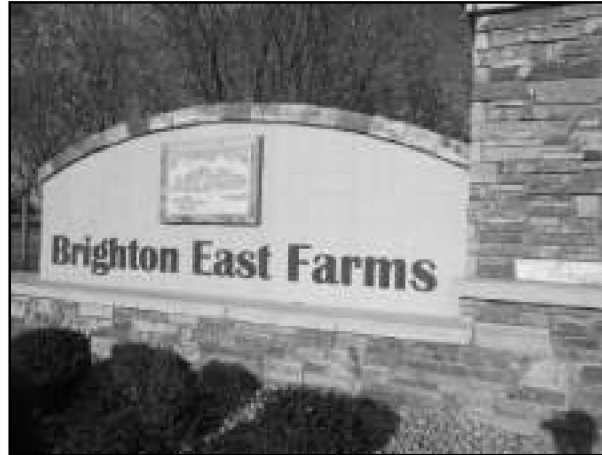
Comp #: 2181 Sign/Monument - Refurbish/Replace

Useful Life:
30 years

Remaining Life:
14 years

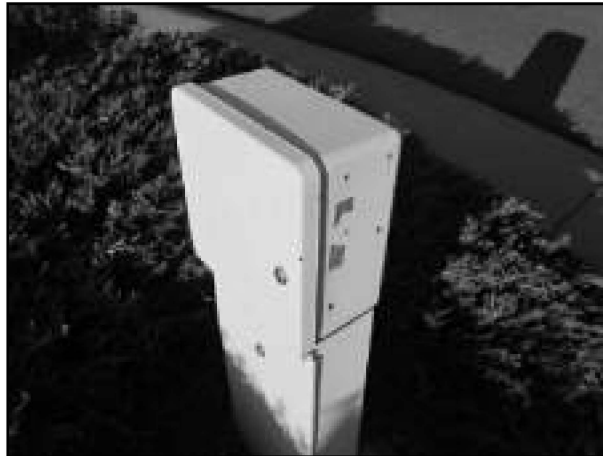
Comp #: 2579 Irrigation Clocks - Replace - 10%

Useful Life:
2 years

Remaining Life:
1 years
